Manhole Inspection Summary

Manhole # S13CC2022MH

Location Address: **2201 CREST RD** Cross Street: **RIDGEDALE RD**

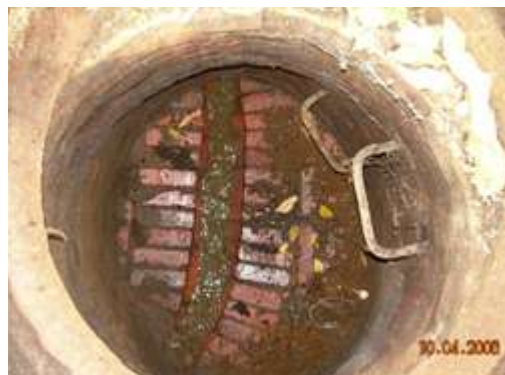
Top View

Adjustment root intrusion and infiltration.
Bench debris.

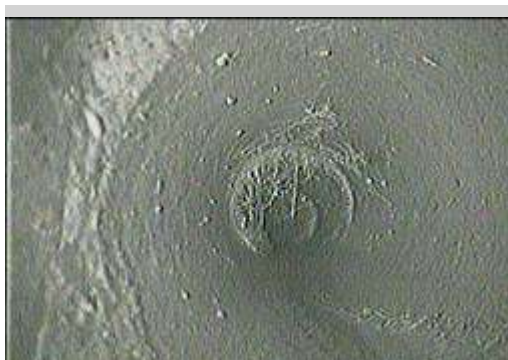
Inside the O12

Root intrusion.

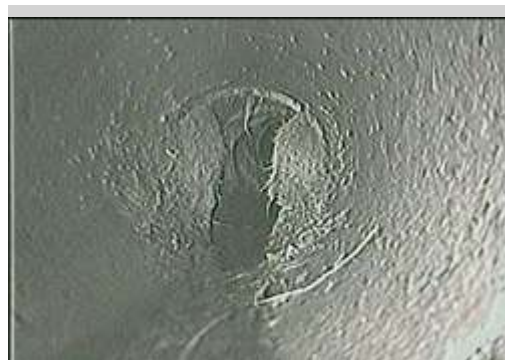
Inside the I7

Root intrusion.

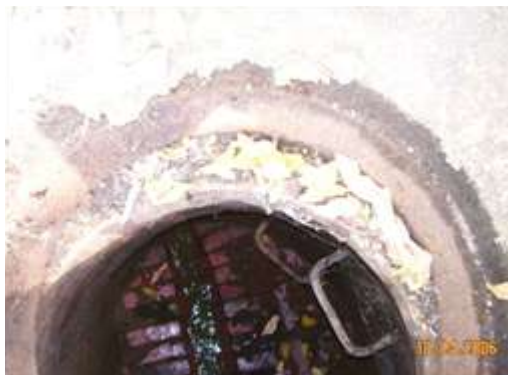
Defect

Frame Offset: **5** (in.) Condition: ☐ Sound ☐ Cracked ☒ **Leaks**

Frame leak. Frame offset.

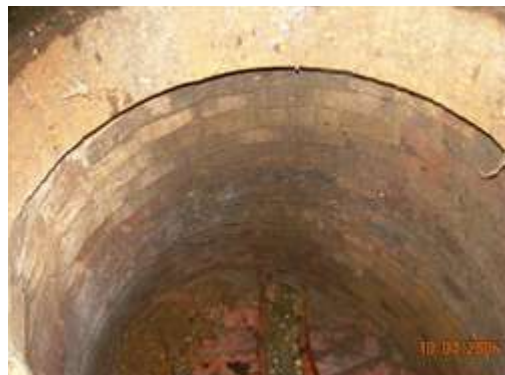
Defect

Chimney / Frame Adjustment ☒ Exists Material: **Brick** ☐ Parged Height: **4** (in.)
Condition: ☐ Sound ☐ Cracked ☒ **Root Intrusion** ☐ Loose Brick ☐ Deteriorated
Infiltration: ☐ None ☒ **Joint** ☐ Cracks ☒ **Mortar** ☒ **Roots** ☐ Wall

Corbel Material: **Brick** ☐ Parged Type: **Concentric/Eccentric**
Condition: ☒ Sound ☐ Cracked ☐ Root Intrusion ☐ Loose Brick ☐ Deteriorated
Infiltration: ☐ None ☐ Joint ☐ Cracks ☒ **Mortar** ☐ Roots ☒ **Wall**

Adjustment, Corbel and Barrel infiltration.

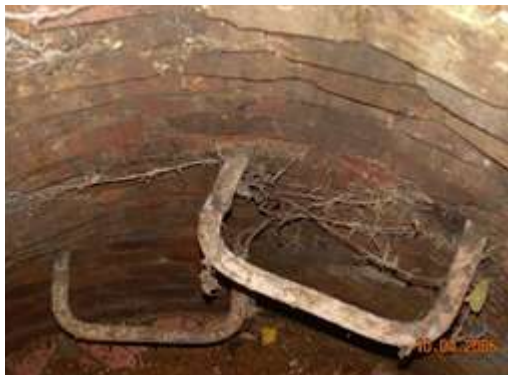
Defect

Barrel Material: **Brick** ☐ Parged
Shape: **Circular** Diameter: **42** (in.) Length: (in.)
Condition: ☐ Sound ☐ Cracked ☒ **Root Intrusion** ☐ Loose Brick ☐ Deteriorated
Infiltration: ☐ None ☐ Joint ☐ Cracks ☒ **Mortar** ☒ **Roots** ☒ **Wall**

Barrel root intrusion and infiltration.

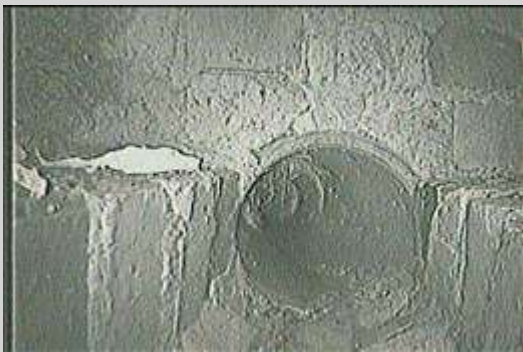
6 in. Circular Gravity Sewer Pipe Out @ 12 O'Clock

Infiltration: **Evidence** Pipe Seal Cond: **Cracked**

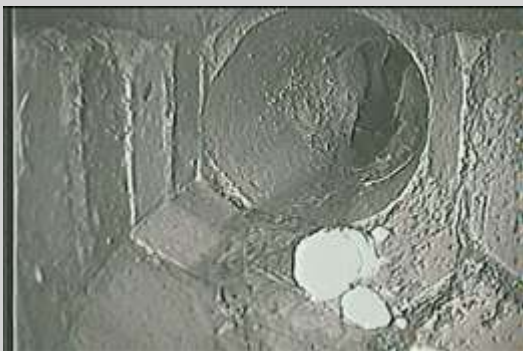
6 in. Circular Gravity Sewer Pipe In @ 7 O'Clock

Channel root intrusion.

Infiltration: **Evidence** Pipe Seal Cond: **Unknown**
